Exhibit B

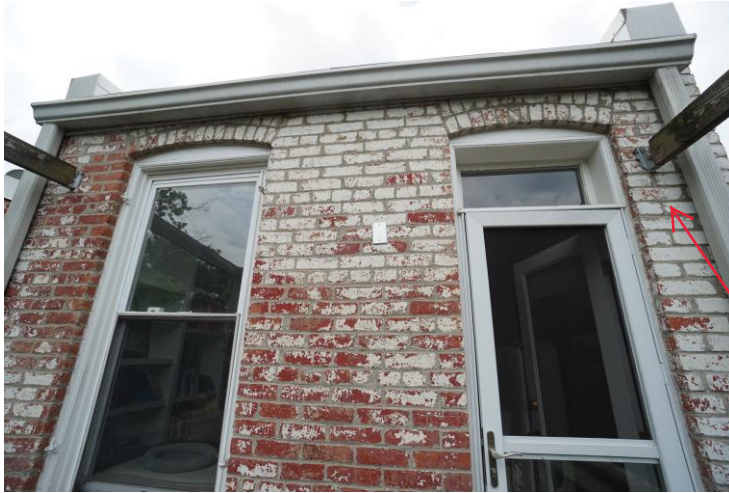
UPPER FRAMING OF BALCONY IS COMING OFF OF THE REAR WALL

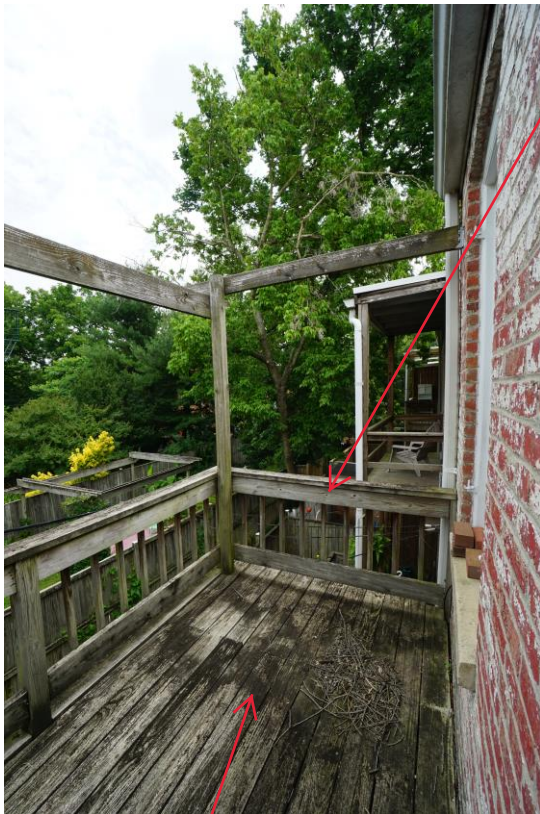
DECKING IS DETERIORATED

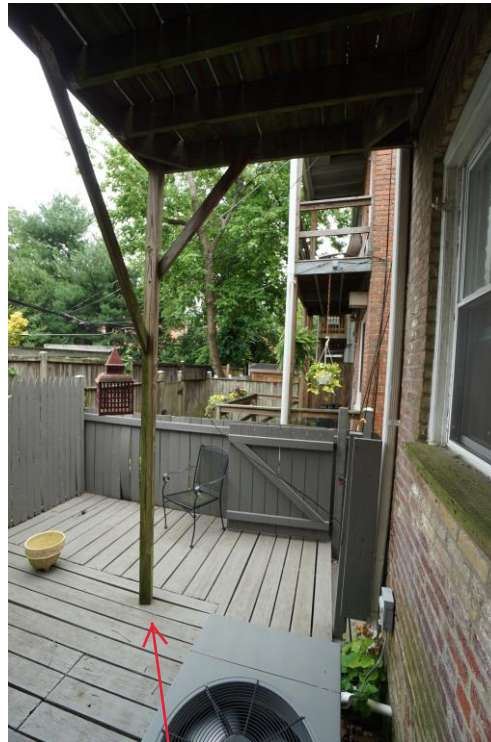
GUARDRAILS ARE 30" TALL

POSTS OF BALCONY ARE BEARING SOLELEY ON THE DECKING BOARDS OF THE EXISTING GROUND FLOOR DECK
